## Chapter 4 – Environmental and Social Baseline

Vares Polymetallic Mine ESIA  
Final V1.0

February 2022

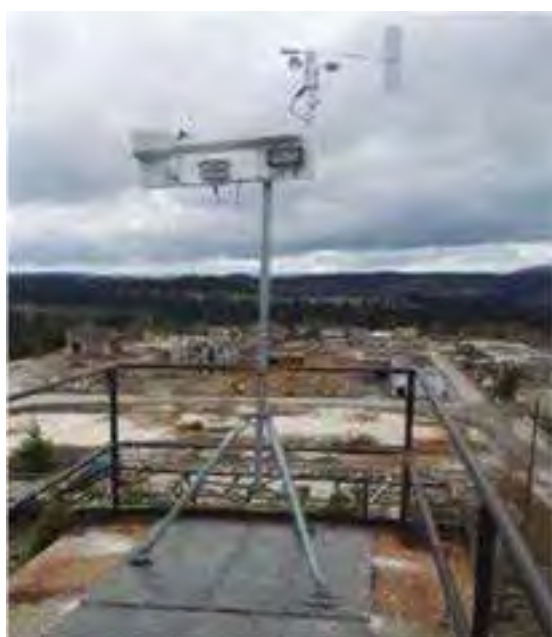
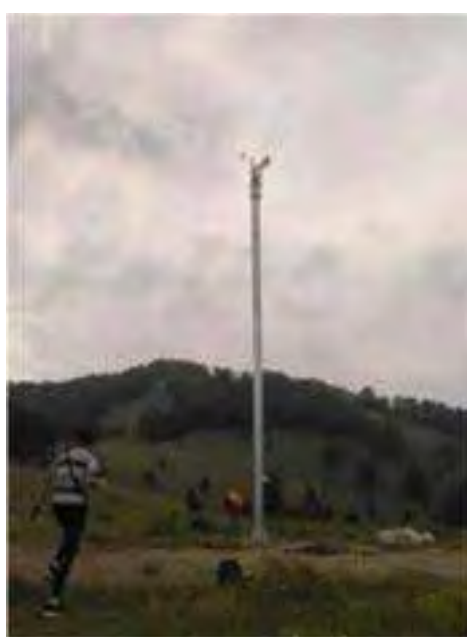
**Photo 4.2.1: Weather Stations (left Vares Process Plant, right Rupice)**

The weather stations collect all relevant and required information namely temperature, humidity, rainfall, wind direction, wind speed and radiation. Results from the weather stations are collated and are prepared into monthly reports, according to BiH legislation. Each parameter is reported on a day-by-day basis for the hours of 0700, 1400 and 2100. Reports also include average values for each parameter.

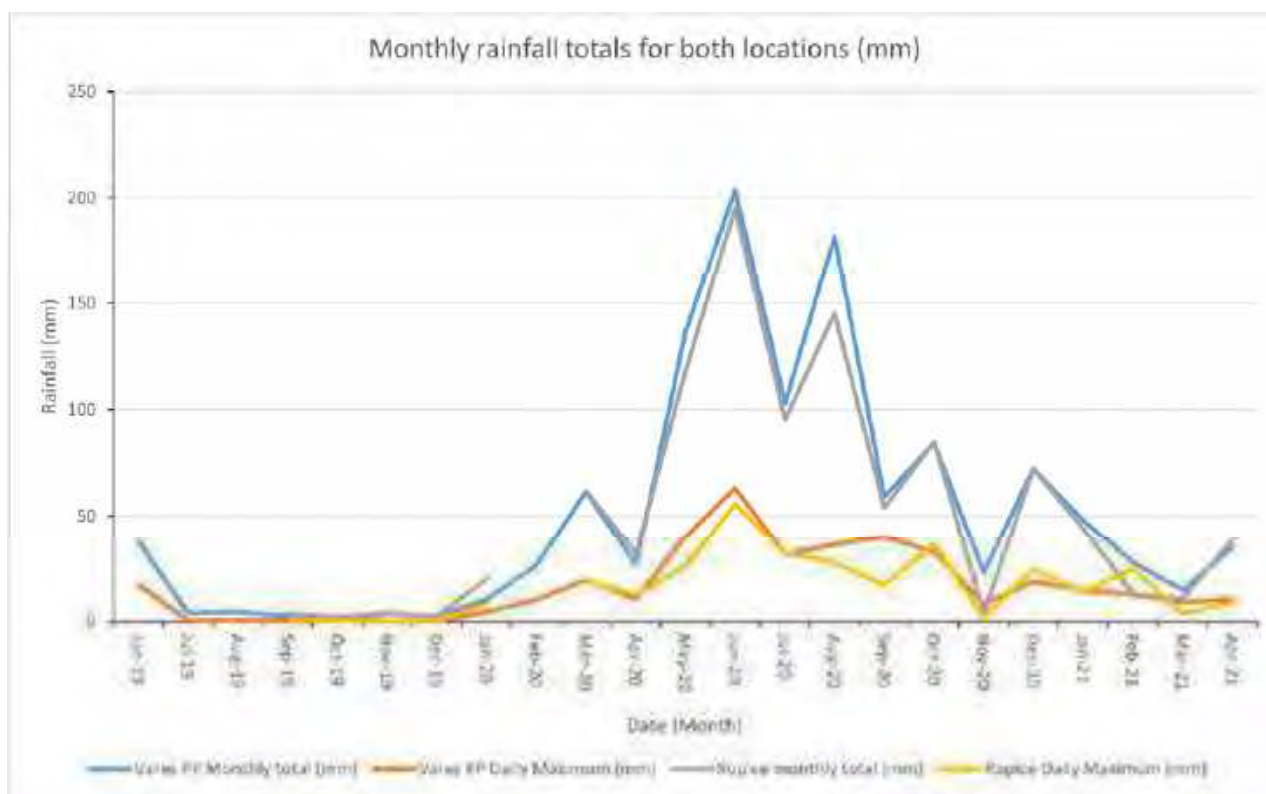
**Figure 4.2.3: Monthly precipitation totals at Vares PP and Rupice**

NB: Values not available for Feb 2020 at Rupice due to erroneous results

The region is characterised by high relative humidity levels. Both sites exhibit similar rainfall patterns with most of the rainfall occurring during summer months (May – September), and least rainfall during the winter months. The annual rainfall recorded at Vares Process Plant (1017.2mm) is higher than the rainfall received at Rupice (907.8mm) during the same time (April 2020 – April 2021). Figure 4.2.3 provides the records of precipitation at both the sites.

The minimal rainfall received between June 2019 and January 2020 at Vares Process Plant compared to the other months was likely due to an unsuitably positioned weather station. This was moved to a new location (X: 6528314; Y:4888570) in April 2020 to be at a more suitable height from the ground and less exposed to updraft. Additionally, the gap in rainfall data at Rupice for February 2020 is due to anomalous data recorded. This months’ data has therefore been excluded from the analysis due to its unrepresentative nature.

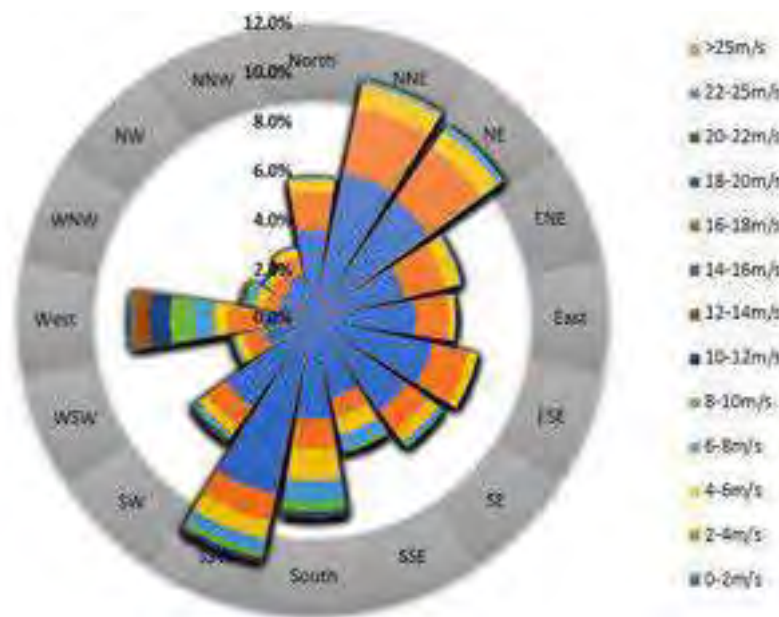
Figure 4.2.5: Wind Rose - Rupice (May 2020 – April 2021)

Site wind data used in this report was collected over a twelve month period between May 2020 and April 2021, as within these months the data was consistently logged every 15 minutes from the same two met stations; Rupice and Vareš PP, thus ensuring continuity in the dataset. Prior to April 2020, the previous meteorological station at Veovača experienced updraft exposure and hence the data collected was likely to be unrepresentative of the true wind conditions for the proposed site, while

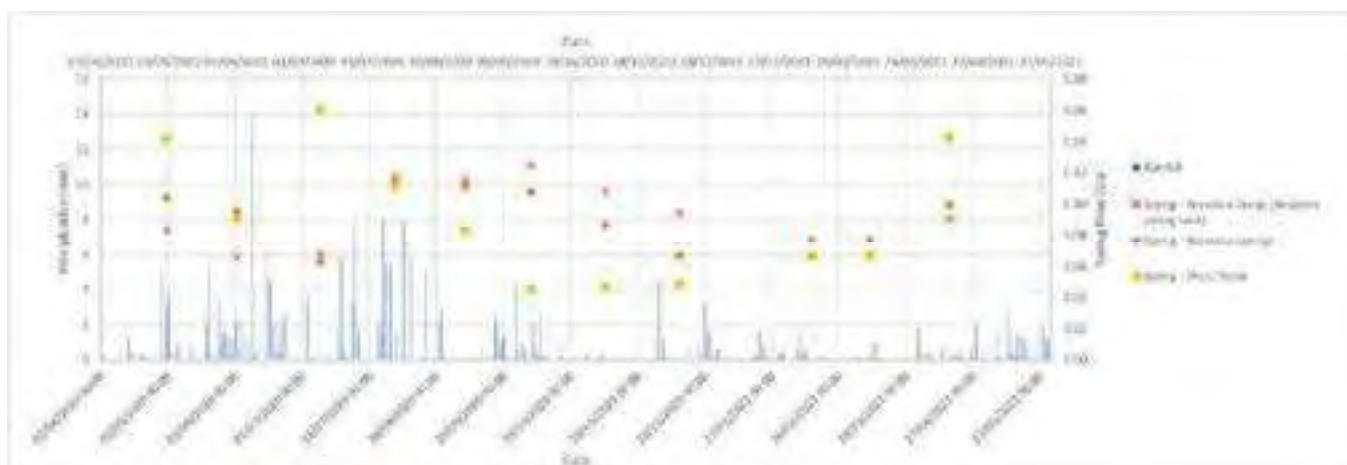
**Figure 4.9-6: Spring Flows from Manual Measurements with Monthly with Precipitation**

Flow rates within springs in the Rupice Concession, identified in Table 4.9.4, have been recorded on a monthly time-step, between April 2020 and May 2021, at the same time as water quality samples were taken. Spring flow rates were recorded using a stopwatch and container. Results from monitoring vary between 1l per 6.2 sec on 08/07/2020 to 1l per 22 sec on 10/10/2020. Figure 4.9-6 indicates spring flow rates with precipitation recorded at the three springs displayed in Table 4.9.4.

Flows within the Vrući Potok Spring appear the most varied, recording the highest and lowest Spring flow rates during the monitoring period. In general, spring flow rates appear to follow the rainfall hydrograph, recording highest flows following periods of high rainfall (spring months) and lowest flows during periods of low rainfall (summer months and winter freezing conditions). Flow rates are at their greatest in April 2020 and 2021 and October 2020.

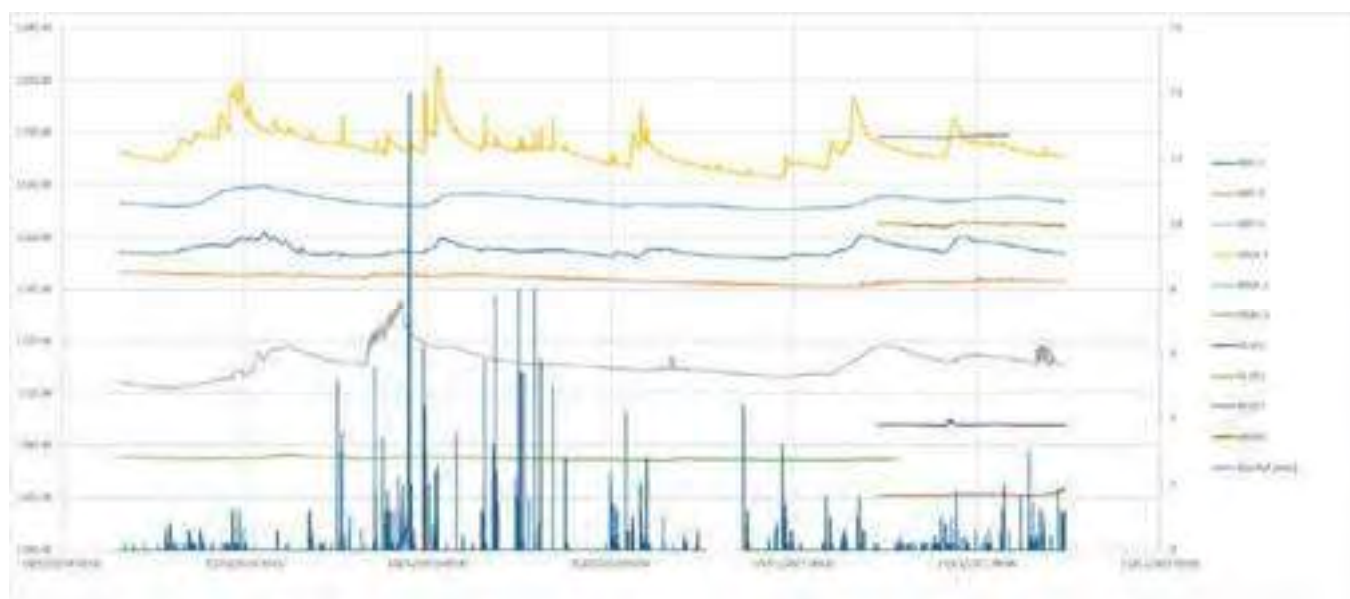
**Figure 4.9.13: Groundwater Elevations (Rupice) Versus Rainfall (May - November 2020).**

Results from automated pressure transducer monitoring within the Rupice groundwater wells have been plotted with rainfall data recorded within the Rupice concession and are provided in Figure 4.9.13 below.

Groundwater elevations within BRW-2, BRW-3, BRP-1 and BRP-2 display a relatively stable groundwater condition with elevations remaining relatively consistent throughout the monitoring period. Groundwater elevations within BRP-3 display increasing groundwater elevations (approximately 20m increase) from mid-late May 2020, corresponding to a period of prolonged rainfall within the area. Groundwater elevations in BRW-1 display a more dynamic groundwater hydrograph,

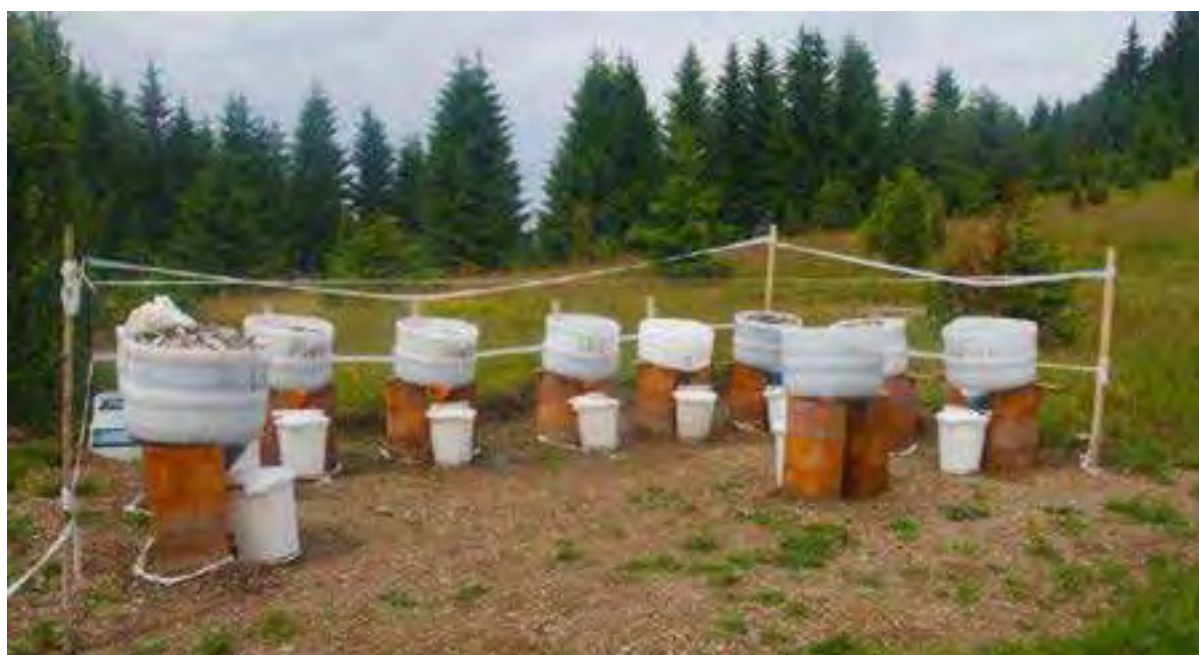
**Photo 4.10.1: Field Leach Trials set up at Rupice**

Field leach-pad trials initiated at the Rupice site have been running since April/May 2020, testing each of the characterized units, using core selected by examination of the drill-hole database. Ore material was collected from samples rejected from metallurgical testing as described above. This and broken core composited from each waste unit type were loaded into plastic drums open at the top for rainfall and free draining at the bottom for effluent collection. A mixed reactive and unreactive sample was also included to assess the effect of co-disposal (of PAG and NAG waste) on acid generation and metal leaching; and a blank. Effluent volumes are measured after every significant rainfall event and samples taken for hand-held measurement of pH/Conductivity/dissolved oxygen and alkalinity. Monthly samples have also been collected since May 2020 (when there is sufficient effluent) and sent to the laboratory in Tuzla for chemical analysis. Unfiltered samples have been used for analysis, but one round of sampling was sent for analysis of both filtered and unfiltered effluents to determine dissolved- and particulate- contaminate levels.

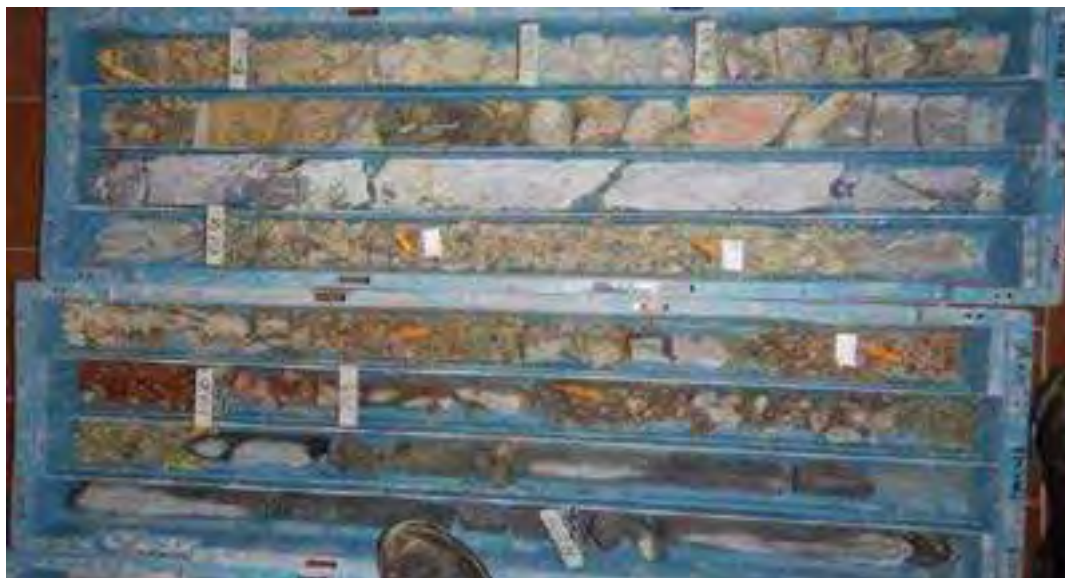
**Photo 4.10.2: FWMISED 2017 Core Showing Reaction During Storage and Low-pH Values**

features, the reactive rock has been logged, and where necessary tested, through drill-core that has been stored for >14months, on all 2017 and 2018 core and some of the earlier 2019 core, and the information plotted on drill sections. Modelling was then undertaken to develop a wireframe showing the distribution of these MISED materials.
